SUPPLEMENTARY ADVISORY

Convenience at a Cost

Changing Catheters Over a Wire

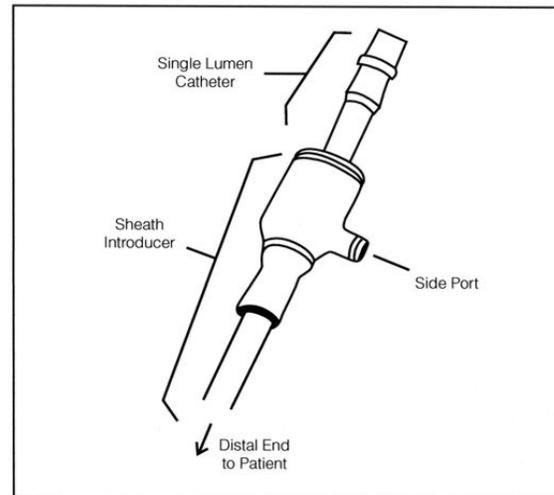
Figure 1. Sheath Introducer and Catheter Assembly

An intravenous infusion catheter is placed, usually in a large central vein, to administer various intravenous fluids and agents. A percutaneous sheath introducer is used to insert and maintain the catheter placement in a vessel. Figure 1 shows the catheter inserted into the introducer. The side port of the sheath introducer is used to infuse fluids into the bloodstream.

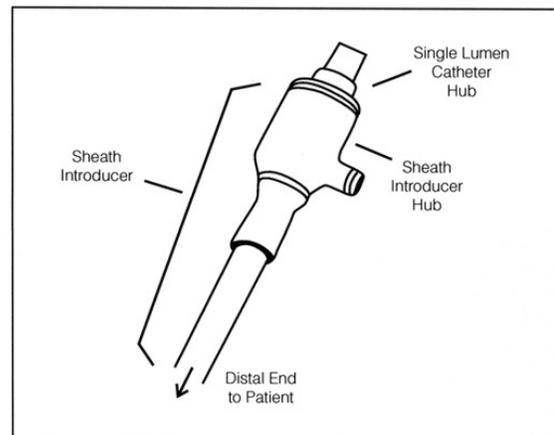
Figure 2. Catheter Hub Positioned against Sheath Hub

Figure 2 shows the catheter inserted further into the introducer to the point where the catheter hub is resting against the introducer hub.

The sheath introducer hub acts as a stop for the catheter and, on some models, provides a mechanism to lock the catheter to the introducer to prevent unintentional catheter movement. Cutting

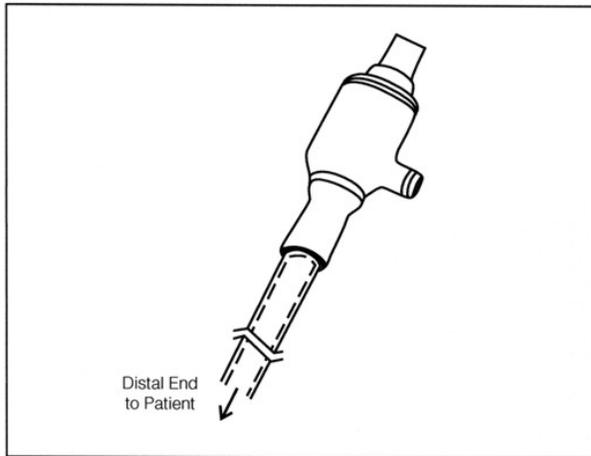
Figure 3a. Sheath Introducer and Catheter Modified (Cut)

According to the facility, a resident physician was unfamiliar with this particular type of catheter and did not realize that cutting the outer sheath introducer below its hub also cut an inner catheter, freeing it from its hub. Confusion may be compounded by the fact that when the hub of the catheter is positioned against the hub of the sheath introducer; the sheath and catheter may appear as a single device.

below the hub of the sheath introducer removes this anchor. Figure 3a shows where a cut might be made below the hub of the introducer and catheter assembly to introduce a new catheter. A Seldinger guidewire inserted into the introducer to guide the placement of a new catheter into the vein pushes the free-floating original piece of infusion catheter into the patient's bloodstream. The small arrows in Figure 3b show that when the guidewire is pushed

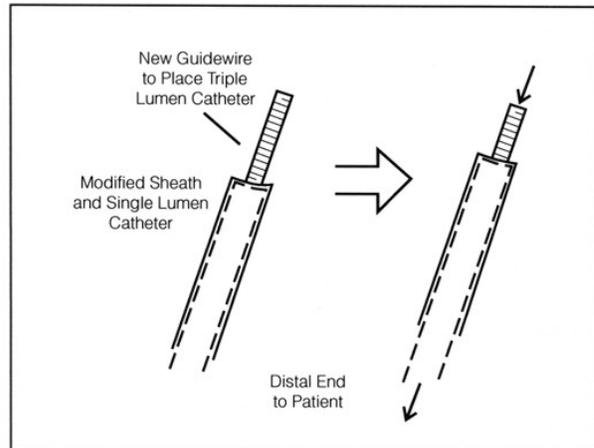
Figure 3b. Single Lumen Catheter Pushed into Bloodstream

further into the sheath introducer, the inner catheter is pushed further distally into the patient's bloodstream.
